**PUBLIC NOTICE**  
**Industrial Wastewater Closure Module for Liquid Waste Tank 16H**  
**H-Area Tank Farm, Savannah River Site**  
**Available for Public Comment**

**INDUSTRIAL WASTEWATER CLOSURE MODULE FOR  
LIQUID WASTE TANK 16H  
H-AREA TANK FARM, SAVANNAH RIVER SITE**

**February 2015**

**Industrial Wastewater Construction Permit No. 17,424-IW**

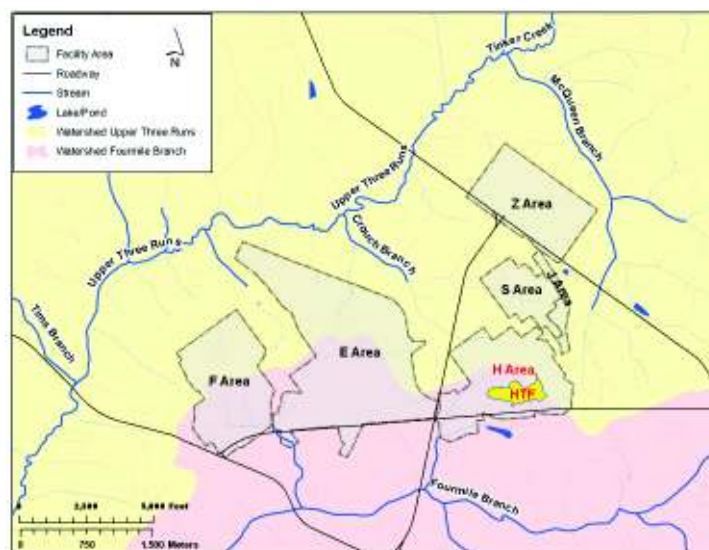
Figure 2.0-1: Layout of the GSA

The HTF site was chosen because of its favorable terrain and its proximity to the H-Canyon Separations Facility (the major waste generation source), which was located near the center of the site, away from the SRS boundaries. Figure 2.0-1 shows the setting of H Area and HTF within the General Separations Area (GSA).

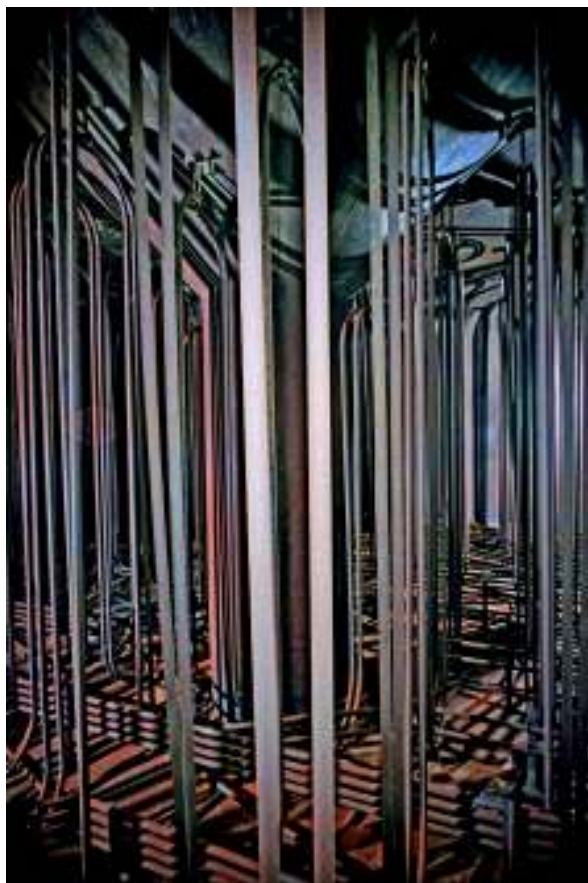
**Figure 2.1-3: Tank 16H Center Column and Cooling Coils**

The Type II tanks have 44 cooling coils inside the primary tank. There are 40 vertical cooling coils arranged in 22 sections (rows) supported by hanger and guide rods that are welded to the roof and floor of the primary tank. The coils are approximately 24 feet high

and extend from 8.5 inches above the floor to 2 feet 3 inches below the roof. The coils nearest the support column were field fitted and are shorter. Four horizontal cooling coil runs extend across the bottom of the primary tank and are supported by guide rods and steel angles welded to the primary tank floor. The floor coils are generally arranged in 20 row runs set at 90 degrees to each other. The centerline of the upper and lower coil run pipes are 5 inches and 2 inches above the floor, respectively. In some areas the runs are parallel and coils are stacked four high (Figure 2.1-3). [W163658] All cooling coils are 2-inch inside diameter, schedule 40 carbon steel seamless pipes. The total coil length is 29,400 feet. [W163593] Figure 2.1-3 shows the Tank 16H cooling coils and center support column.

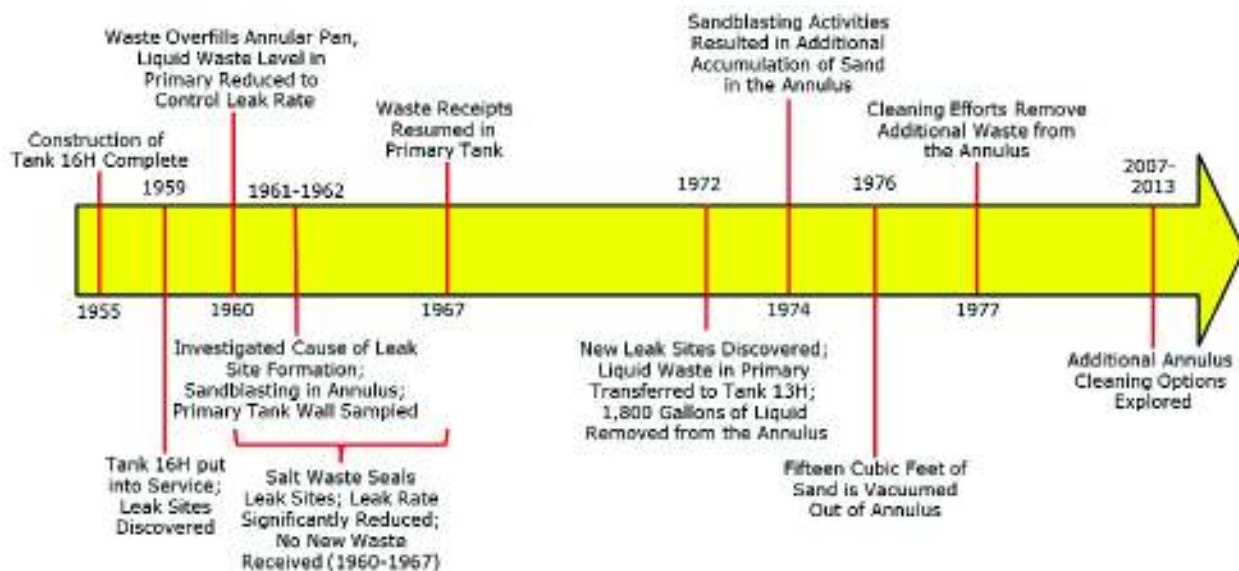
Figure 3.2-1: Tank 16H Annulus Historical Timeline

Figure 3.2-1 shows the Tank 16H annulus historical timeline. The key events and activities on this timeline are described in this section.

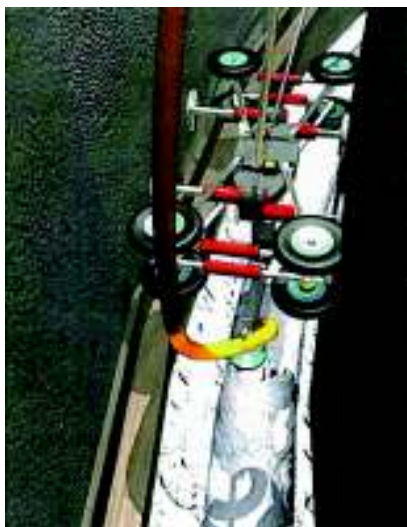
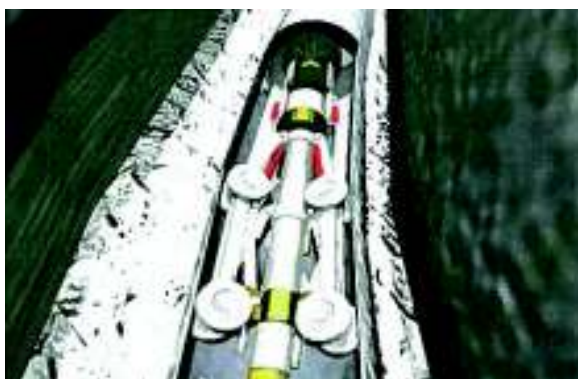
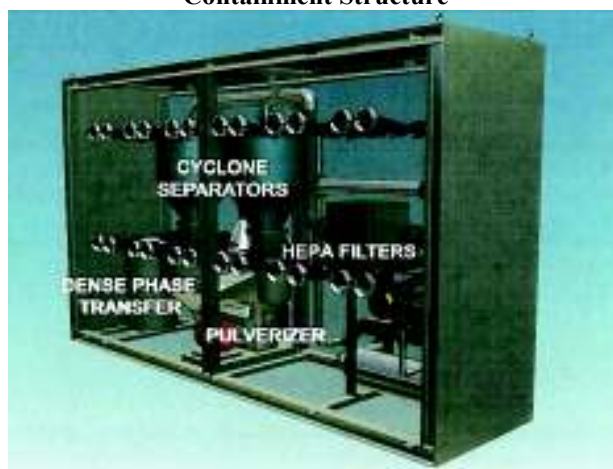
**Figure 3.2-3: SEC Proposed Tank 16H Annulus Cleaning Components**

The SEC system was a mechanical cleaning system. The system consisted of three equipment groups: a manipulator system, a pipe crawler, and a process system for retrieval, material size reduction, and material transport (Figure 3.2-3). The manipulator system would be mounted on a wall crawler. The electromechanical manipulator arm would support various tooling (rotating machine heads, wire brush head and cutoff wheels) for removing the waste and cutting ductwork. The interior duct cleaning would use an electromechanical pipe crawler with interchangeable tooling as well. SEC proposed vacuuming the dry material out of the tank to a process system skid that included a pulverizer. The processed material would then be blown into a dense-phase transfer hopper to be prepared for transport. A 50:50 water to dry media mix would be used for transport. The project team proposed that the dry retrieval approach could reduce environmental risks (from process leakage) and minimize

**Manipulator Cleaning Tank Annulus**

**Pipe Crawler Installed in Pipe**

**Proposed Process Skid**

A proof of principle test was successfully completed in 2007 at the vendor's facility. The test results and information gained were to be used as input for continued design and operating plan development. However, before this could take place, the project was suspended due to fiscal year funding constraints. When funding was reestablished in 2010, the projected cost to design, procure and implement the project was much higher than expected and the new schedule for implementation was extended many months longer than originally forecast. Also, new operability risks were identified based on real-time experience using crawlers in similar radiological applications and the assumed heterogeneity of the annulus waste material. In summary, the vendor proposal would be more difficult to implement, cost more to execute, and take longer than originally planned. Therefore,

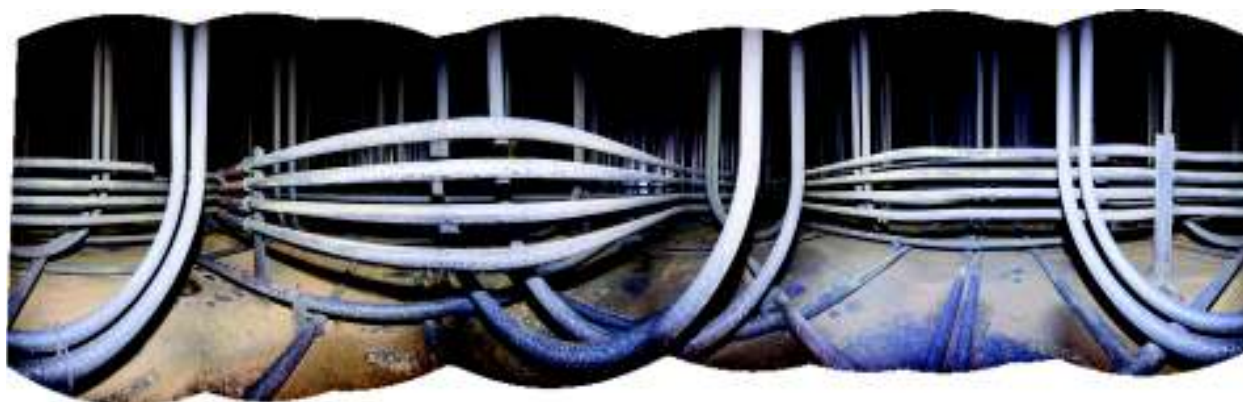
Figure 3.3-1: View of the Tank 16H Primary Tank After Waste Removal

Waste removal details for the primary tank are presented in Section 3.1. Figure 3.3-1 shows the Tank 16H primary tank after waste removal. The overall waste removal effectiveness for the primary tank is summarized on Figure 3.3-2. The percentage of total waste volume removed from the primary tank was calculated at greater than 99.9%. As described in more detail in Section 3.0, the extraordinary success for primary tank cleaning following its early RFS may not be indicative, or possible, for future waste removal efforts on other tanks.

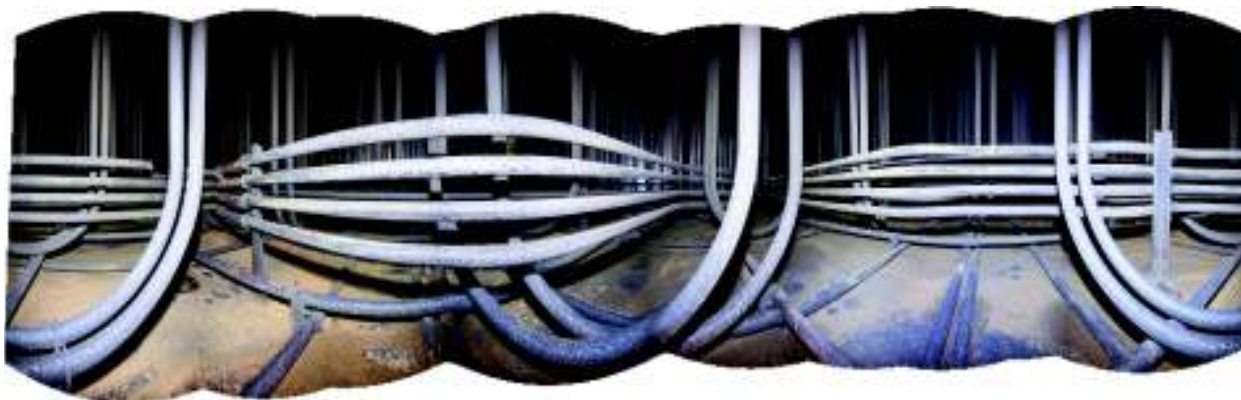
**Figure 9.0-1: View of the Tank 16H Primary Tank After Waste Removal**

- Visual Observation in the Tank Primary – For the Tank 16H primary tank, the determination to cease waste removal activities was primarily based on visual observation. Visual inspections inside the primary tank were performed using remotely operated cameras suspended from waste tank risers and on-board cameras mounted on robotic crawlers used during sampling. These visual observations showed there was a significant reduction in residual material volume as a result of the waste removal efforts. Figure 9.0-1 shows the Tank 16H primary after the completion of waste removal efforts. As described in Section 3.1, extensive waste removal efforts were performed in the tank primary and left only a small amount of remaining residual material.
